Intel[®] Pentium[®] II Xeon[™] Processor Specification Update

Release Date: November 2000

Order Number: 243776-026

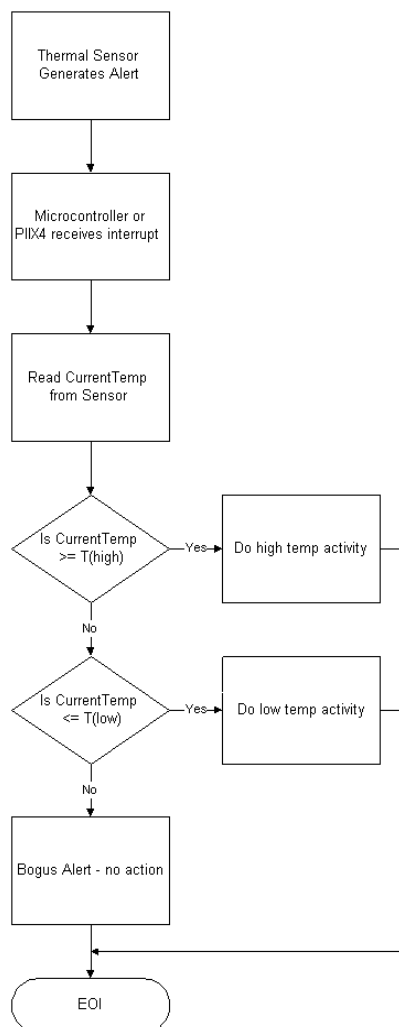
Figure 2. Workaround Flowchart: SMBALERT#-Driven System

D30. Thermal Sensor May Assert SMBALERT# Incorrectly

Problem: The Pentium II Xeon processor has a thermal sensor that monitors the processor core's temperature. The thermal sensor asserts SMBALERT# if the processor temperature exceeds the temperature limits set in the Alarm Threshold Registers (T_{HIGH} , T_{LOW}). It also sets the corresponding Status Register bits to identify the cause of the interrupt. Figure 1 gives one example of how the SMBALERT# signal could be used in a system.

Under the conditions described below, the thermal sensor incorrectly generates the SMBALERT# interrupt. All of the following conditions must be met to trigger a false interrupt:

Workaround: Three different (mutually exclusive) workarounds are possible:

1. Before servicing an interrupt from the thermal sensor, read and compare the processor thermal reading with the threshold limits (T_{HIGH} or T_{LOW}). Figures 2 and 3 provide basic flowcharts for the implementation of this workaround in an interrupt driven system.
2. If the firmware implemented polls the Status Register only, then before taking any action, re-read the temperature register and do a comparison with the alarm threshold limits (T_{HIGH} or T_{LOW}) to determine if the value is actually still within the temperature window.
3. Use a temperature polling scheme to monitor the processor temperature
